# Flood Investigation Report

Woodbrook Road  
Project number: 60624359  
Royal Borough of Greenwich

April 2023

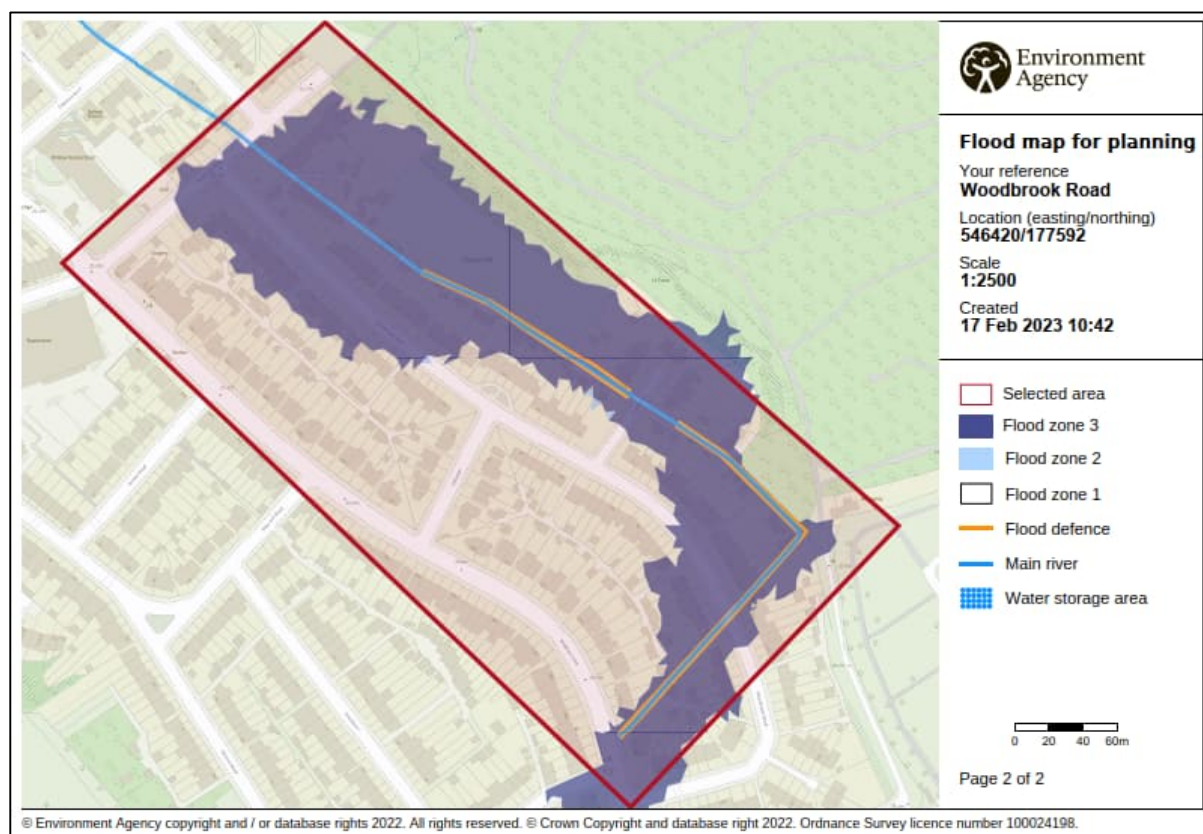
Figure 3: Fluvial flood risk (EA, 2022)

- 4.2 According to the EA's Long Term Flood Risk Service portal, available on the gov.uk website, Marsh Dykes (Woolwich) is classified as 'main river', and the area is defined to be at very low risk of flooding from rivers (less than 1 in 1000 year or 0.1% AEP) while the risk of tidal flooding is within Flood Zone 1 (< 0.1% AEP). However, the EA's Flood Map for Planning Service indicates the area to be within Flood Zone 3 and therefore has a high probability of flooding (see Figure 3).
- 4.3 According to RBG, the residents of the Woodbrook Road area have in the past received a letter from the EA confirming the watercourse is 'main river'.

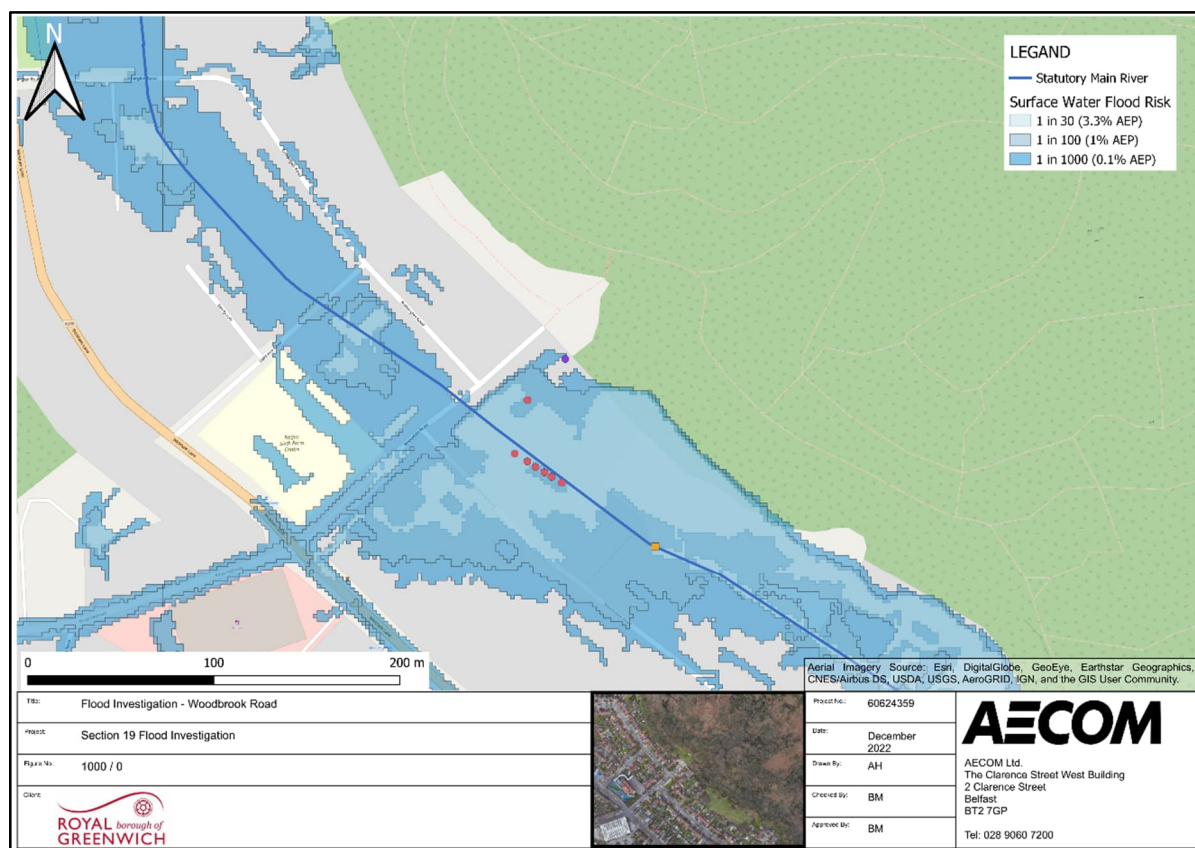
**Figure 4: Surface Water Flood Risk**

- 4.4 According to the Risk of Flooding from Surface Water mapping, available on the gov.uk website, much of the area is at high risk of surface water flooding (3.3% Annual Exceedance Probability (AEP)) (see Figure 4). Surface water flow pathways of medium to high risk (between 1% to 3.3% AEP) are shown to flow and pond at topographical low points.

- 4.5 A review of LiDAR levels indicates the properties flooded are situated in a slight depression (Appendix D). Without mitigation, this potentially allows surface water to naturally pond in the north-eastern regions of the area.

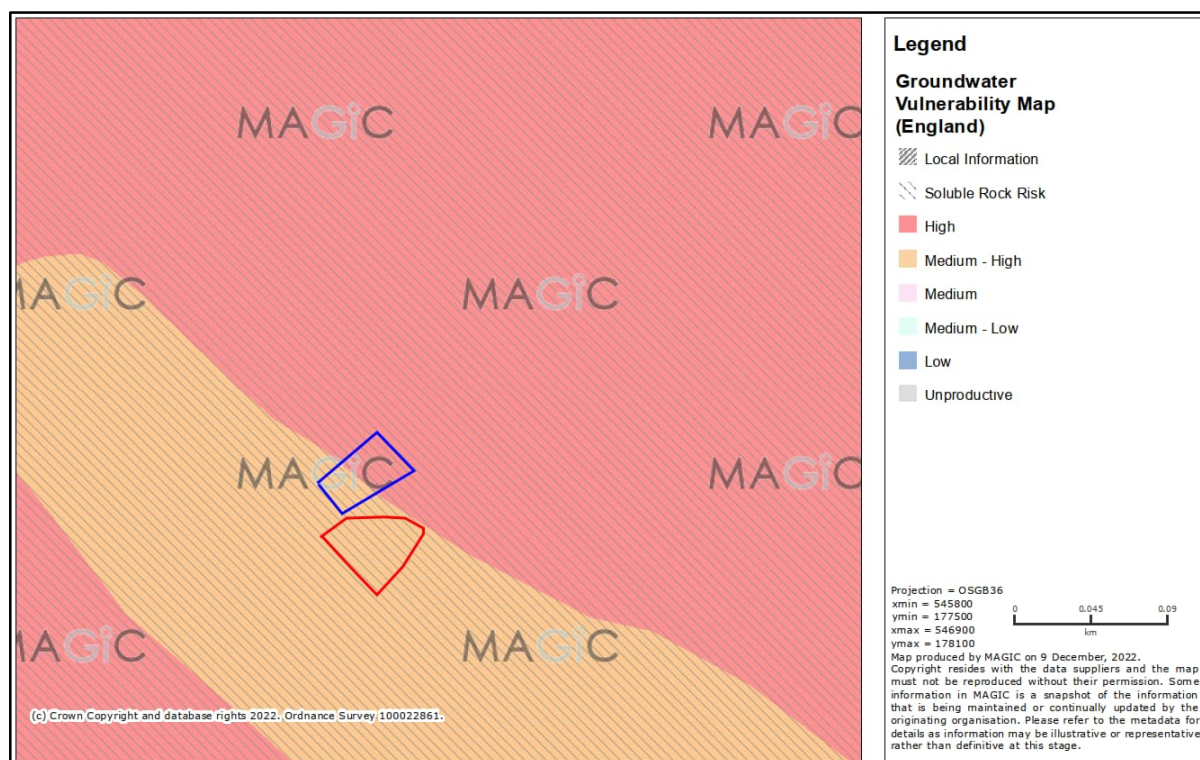
**Figure 6: Groundwater Vulnerability Map (Defra MAGIC, 2022)**

- 4.10 The EA Groundwater Vulnerability Map indicates the internally flooded properties lie within an area classified as medium to high vulnerability while the externally flooded properties are situated within both 'medium to high' and 'high' vulnerability areas. Figure 6 below illustrates the groundwater vulnerability mapping with the internally flooded properties area annotated in red and the externally flooded properties area in blue.
- 4.11 British Geological Society (BGS) mapping shows that the area has a bedrock geology comprising of Lewes Nodular Chalk and Thanet sand, which is largely permeable. BGS mapping indicates the area lies on a small area of sand and gravel superficial deposits. This does not indicate a risk of groundwater flooding, however, shows the vulnerability of groundwater based on the hydrological, geological and other parameters.

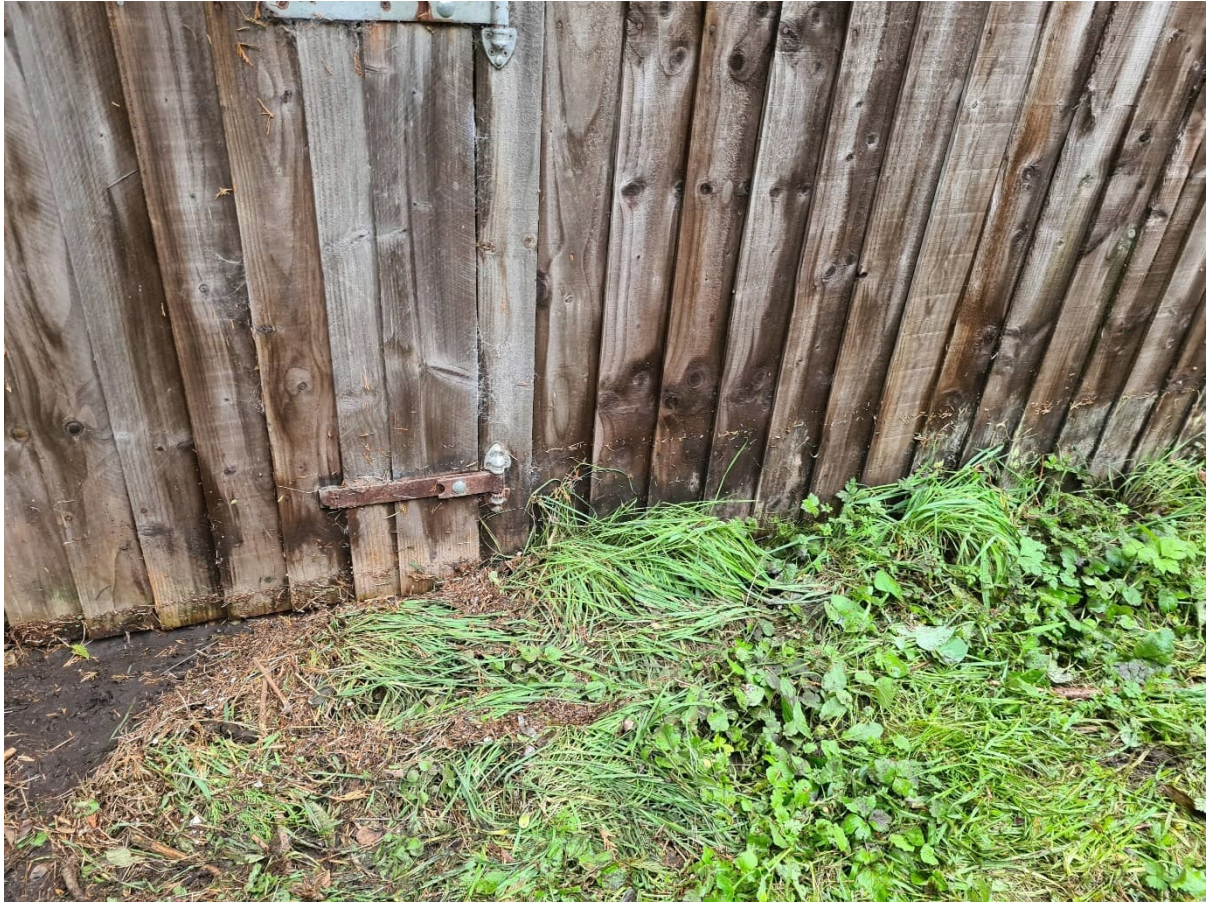
- 4.15 RBG carried out a site visit on the 7<sup>th</sup> November 2022 and were accompanied by TWUL. Markings of where flood levels reached were noted to be approximately 400 to 500 mm at the rear of the internally flooded properties.

**Photograph 1** Water level approximately 300 mm from ground level, reported by RBG (07.11.2022)

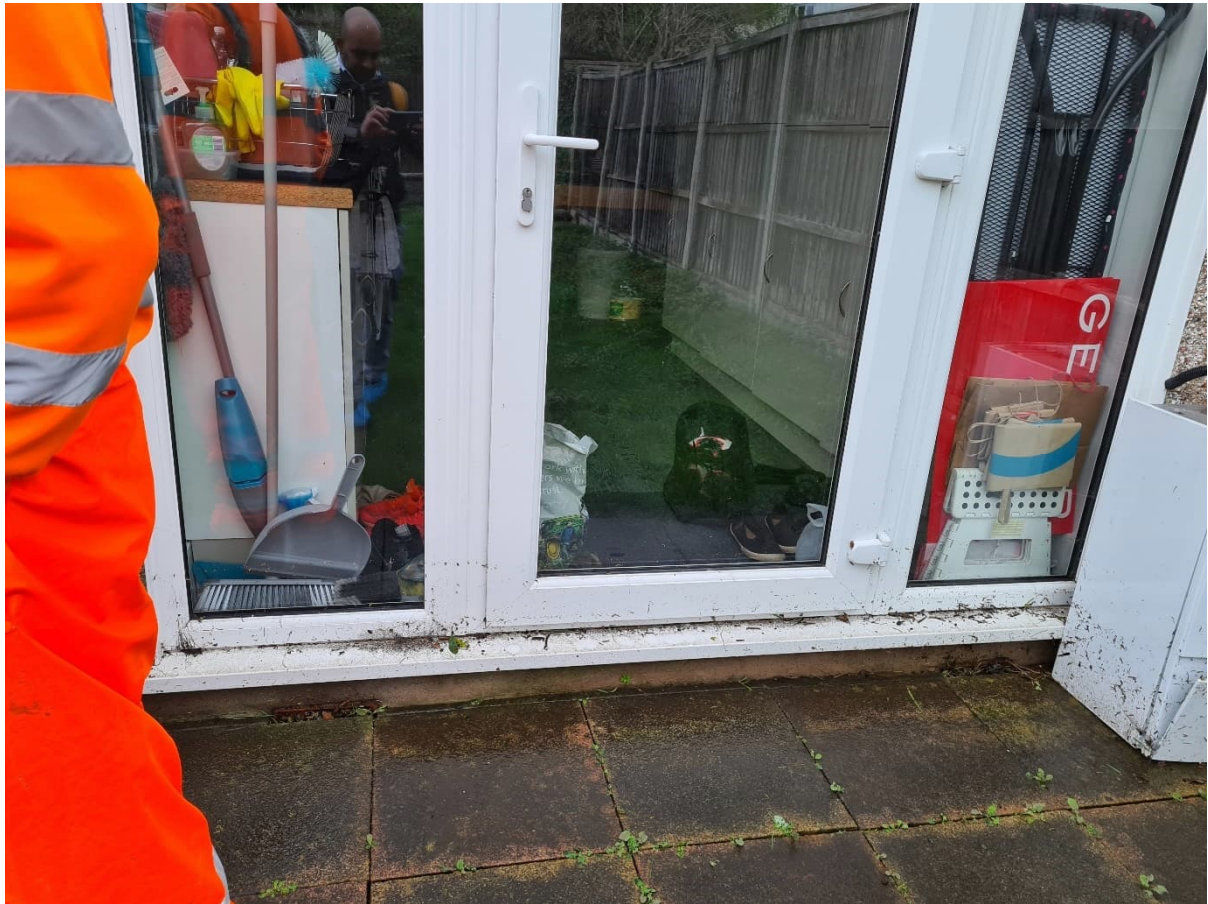
Photograph 2 Rear of property on Woodbrook Road (07.11.2022)

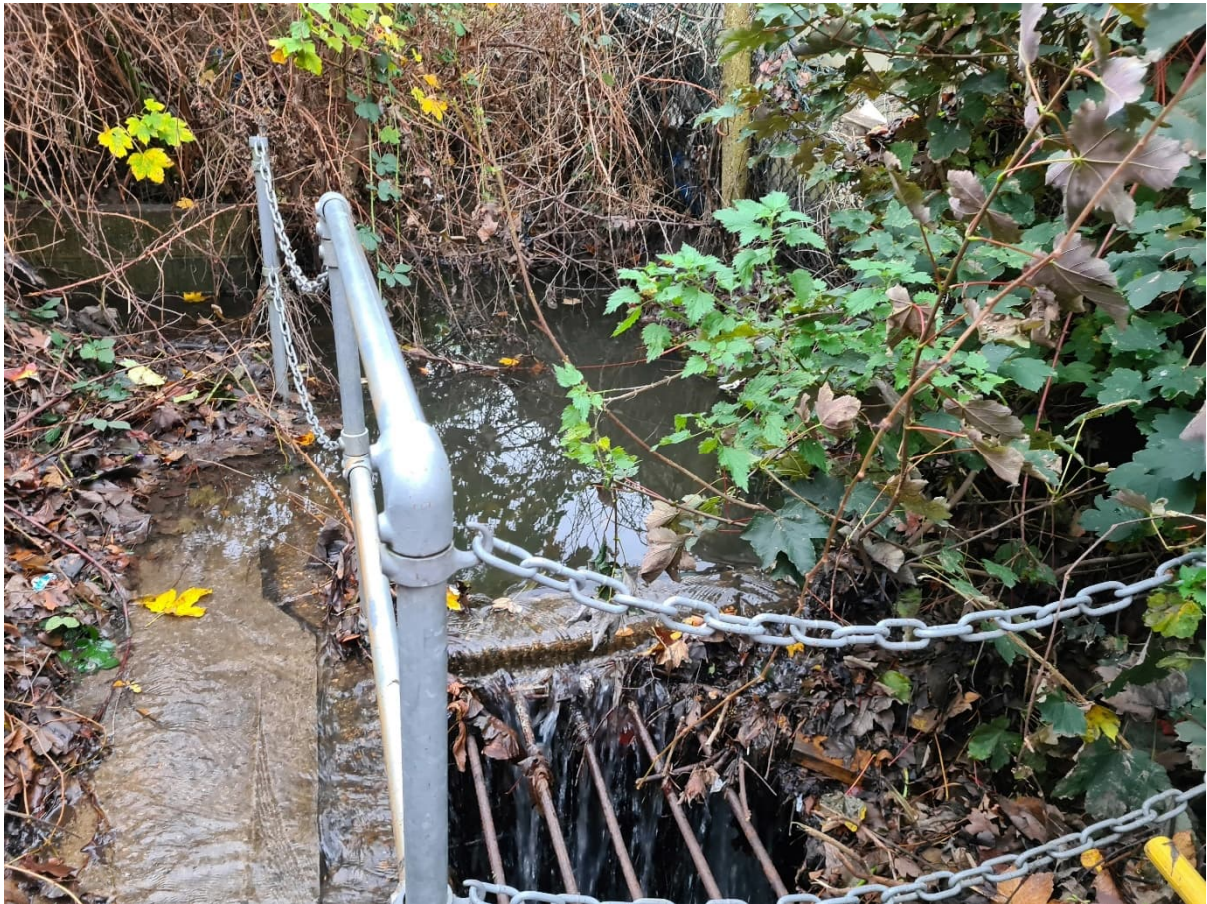
Photograph 3 Pre screen clearance (07.11.2022)

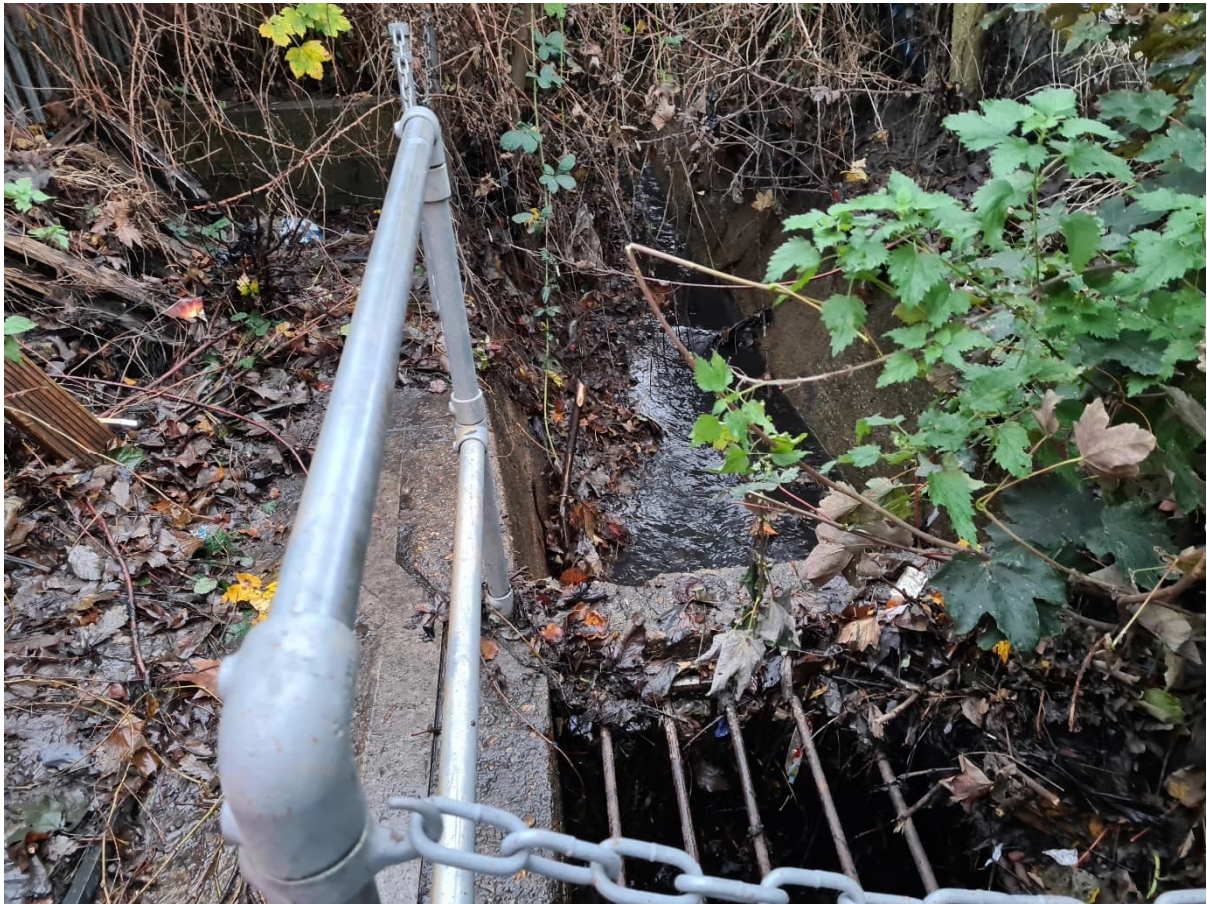
Photograph 4 Post screen clearance (07.11.2022)

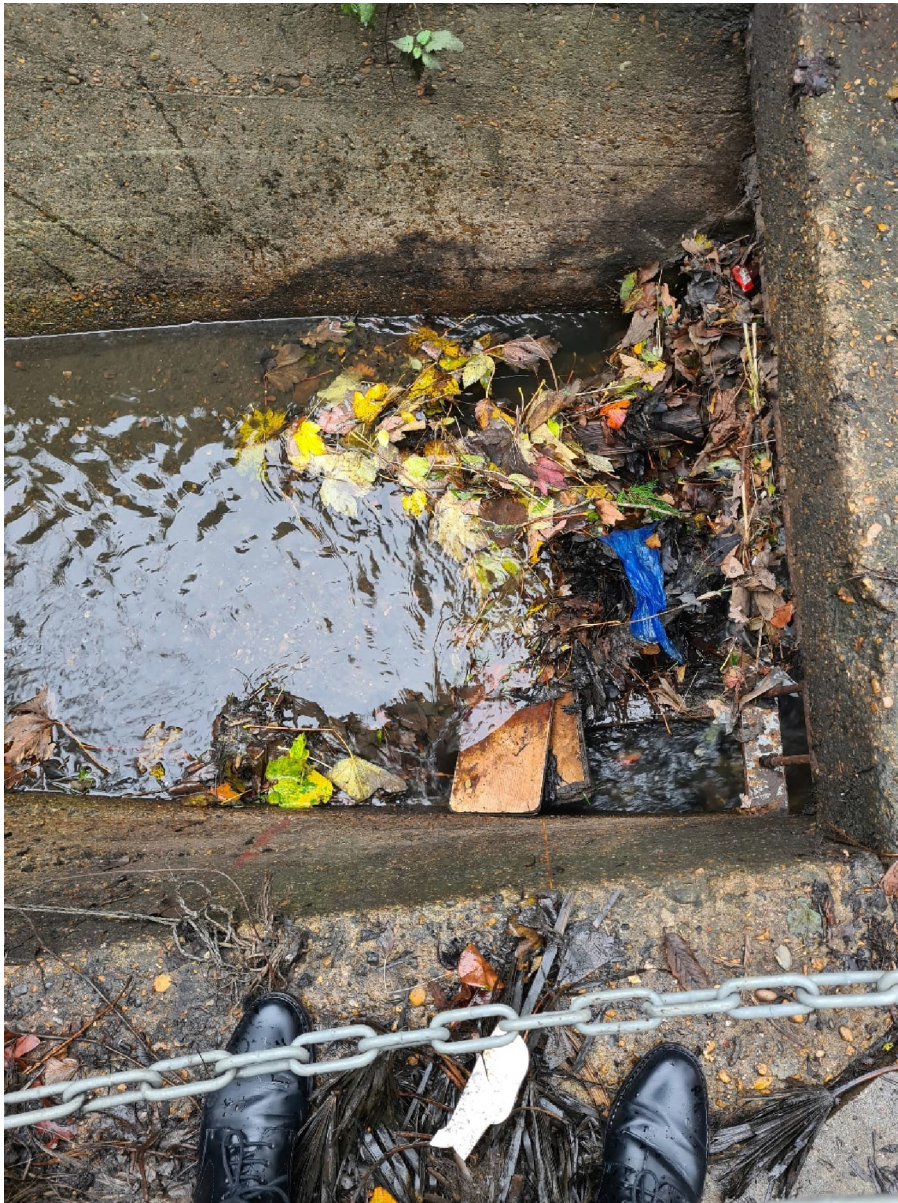
- 5.11 Photographic evidence and anecdotal reports provided by RBG indicated that fallen leaves and tree branches were the prominent debris obstructing the screen. Therefore, a late fall of leaves due to high temperatures during the month of October may have contributed to the acceleration of the screen blockage. To support this theory, mean daily maximum temperature (tmax, C) data was abstracted from the Met Offices 'Historic station data' using both Heathrow (-0.44904, 51.47872) and Eastbourne (0.28543, 50.76167) stations as done previously.
- 5.12 Both Heathrow and Eastbourne climate stations recorded the highest mean temperatures since the stations were installed in the month of October 2022, 18.3 °C and 17.9°C respectively. The temperatures then dropped to 13.2 °C (Heathrow) and 14.1°C (Eastbourne) for the month of November 2022.

**Photograph 5 Debris build up on the screen (29.11.2022)**

| Information | Recommended Actions | Outcome | Responsible |
|---|---|---|---|
| <b>Asset Condition</b> | <ul style="list-style-type: none"> <li>An assessment of the current trash screens to ensure compliance and safe maintenance</li> </ul> | <ul style="list-style-type: none"> <li>A review of the existing screen to determine if compliant and fit for purpose</li> </ul> | <ul style="list-style-type: none"> <li>RBG</li> <li>Environment Agency</li> </ul> |

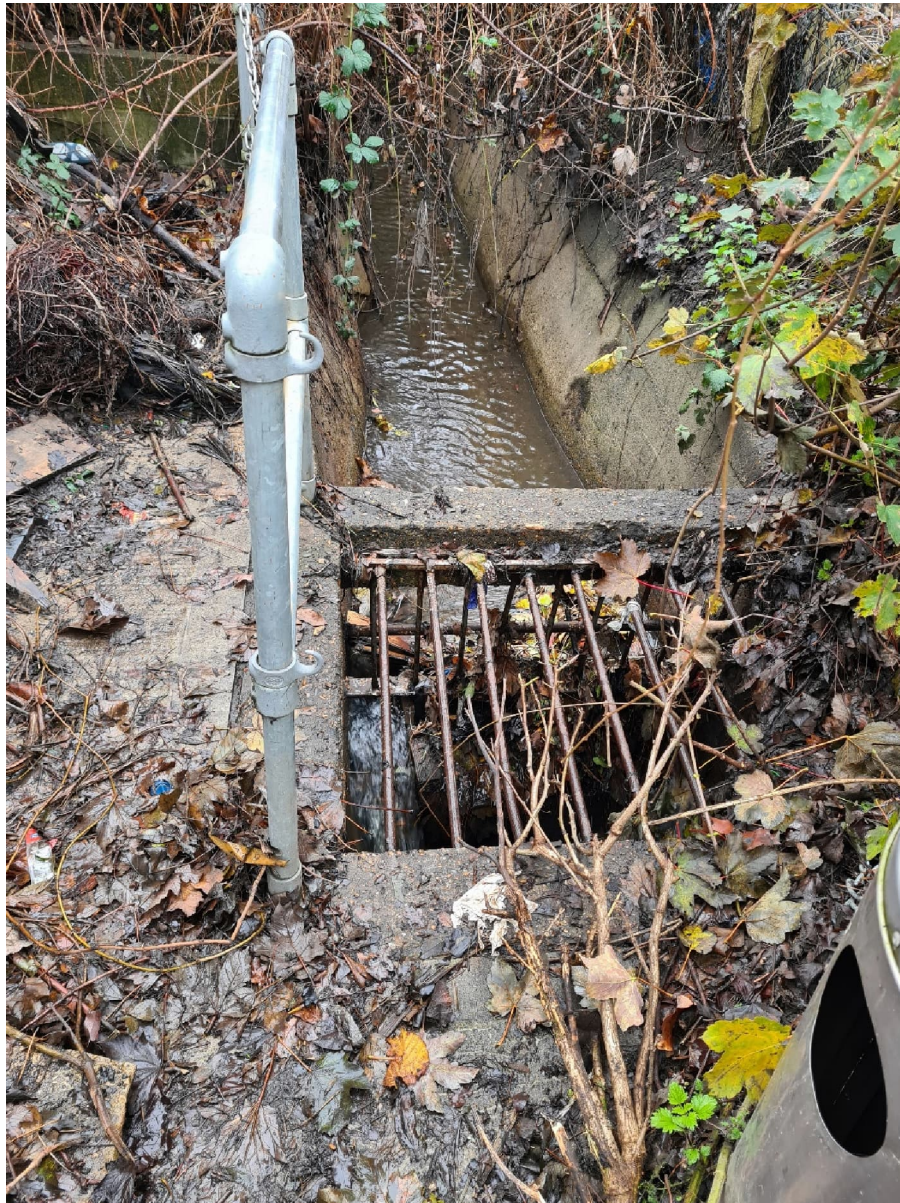
Photograph 6 Alternative view of screen (29.11.2022)
