# Section 19 Flood Investigation Report

Flood and Water Management Act

Royal Borough of Greenwich

Project number: 60731992

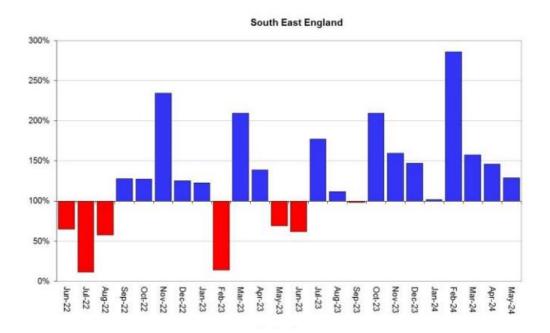
Figure 1-2: Monthly rainfall totals for the past 24 months as a percentage of the 1961 to 1990 long term average for South East England (extracted from Environment Agency Monthly Water Situation Report May 2024<sup>12</sup>)

1.8.3 The Environment Agency Monthly Water Situation Report for May 2024<sup>12</sup> indicates that the three-month cumulative rainfall total at the end of May 2024 was 'notably high' in South East London. As presented in Figure 1-2 the monthly rainfall totals in South East England for the months of March, April, and May equated to 120-160% of the long-term average for South East England.

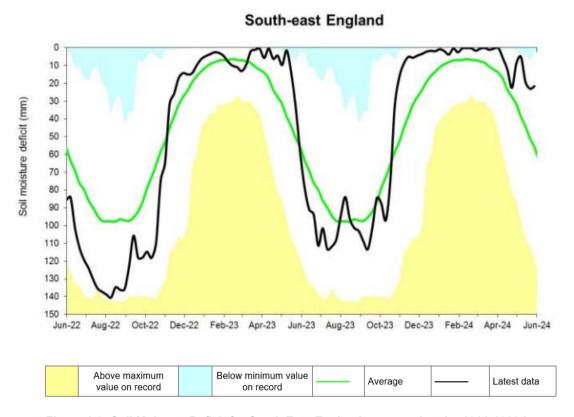
Figure 1-3: Soil Moisture Deficit for South East England compared to the 1961-1990 long term average at the end of May 2024 (extracted from Environment Agency Monthly Water Situation Report May 2024<sup>12</sup>)

1.8.4 As presented in Figure 1-3, the Soil Moisture Deficit (SMD) values in South East England were approximately 20mm-40mm lower in the period November 2023 to January 2024 relative to the long term average for the period 1961-1990 for these months in this region. Additionally, the soils throughout the period November 2023 to January 2024 were at, or within 10mm of field capacity. Field Capacity refers to the maximum amount of water that the soil can hold after all excess water has drained away via gravity, whilst the SMD is the amount of rainwater required to return the soil to field capacity.

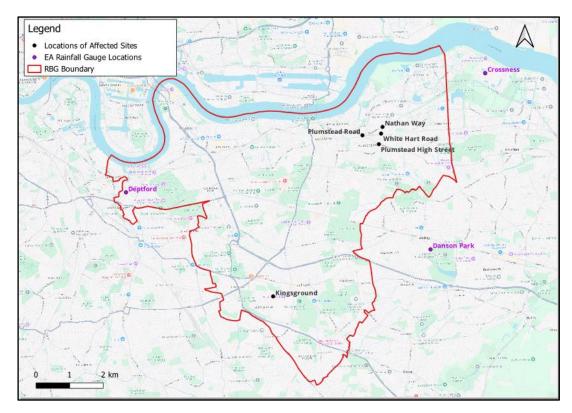
Figure 1-4: Locations of affected sites and local rainfall gauges. © Environment Agency copyright and/or database right 2015. All rights reserved. Map data ©2024 Google.

1.8.5 Observed rainfall data (15-minute time interval) has been downloaded from the Hydrology Data Explorer<sup>13</sup> for the relevant time periods at the three closest rainfall gauges to the affected sites. The names and locations of the three rainfall gauges are presented in Figure 1-4.

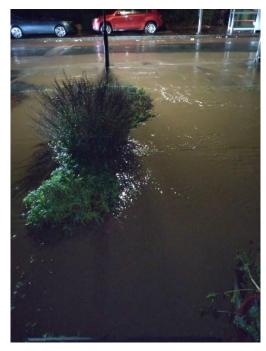
Photograph 1: Front garden of 177 Kingsground

March 2024	Minor flooding in garden of 175 as shown in Photograph 2.

- 2.2.29 Through the assessment of flood mechanisms, several recommendations for improvement have been identified:
  - RBG should ensure routine highway drainage gully cleaning, whilst TWUL should undertake routine monitoring of sewer networks
  - RBG should investigate a solution for reducing surface water runoff across the paddock and
    ensuring surface water is able to enter the drainage network on King John's Walk. Possible
    solutions include constructing a kerb along the edge of the King John's Walk to direct flow into
    the surface water drainage network and prevent flow passing onto the paddock.

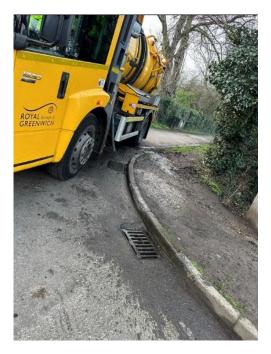
Photograph 6: Three gullies at the junction between King John's Walk and the public footpath

- 2.2.24 Following the above survey, RBG's Street Services team visited the site in early March 2024 and undertook gully clearing. They reported the drains on Court Yard were all unblocked and running free and cleared the gullies on the junction between King John's Walk and the public footpath. The Streets Services team did report that they were unable to access the section of King John's Walk leading up to Eltham Palace Stables as the vehicle was too large.

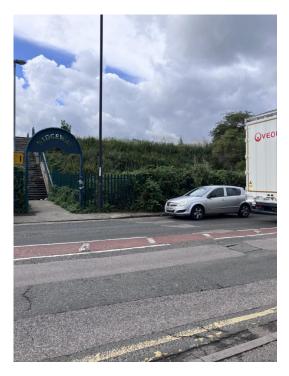
Photograph 10: Low point on Nathan Way adjacent to footpath over the Ridgeway

- 2.3.19 Nathan Way is a C classed road owned by RGB. The site visit at this location was conducted with a member of RGB LLFA and a member of the Streets Services Team.
- 2.3.20 There is an obvious low point on Nathan Way opposite the footpath entrance to the Ridgeway as shown in Photograph 10.
- 2.3.21 It is understood that Nathan Way drains to a combined sewer network, which drains to the Crossness pumping station. There are two TWUL manholes on Nathan Way opposite the Ridgeway, one with a cover level of 0.85. Anecdotal evidence from Street Services Team reported that when Crossness Pumping Station is not allowed to discharge, this backs up the drainage network along Nathan Way and causes surcharging at the manholes. As this is one of the lower manholes on the road, surcharges occur in this location.

- 2.3.29 Through the assessment of flood mechanisms, several recommendations for improvement have been identified:
  - TWUL should investigate upgrading the combined sewer network capacity at White Hart Road and Nathan Way to limit surcharging and ensure that surface water flows can be managed effectively at the lower elevations

- TWUL should investigate whether discharging and failure to discharge from Crossness Pumping Station is causing the drainage network to backup at Nathan Way and White Hart Road

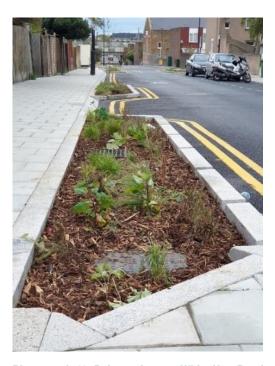
- 2.3.24 Along the length of White Hart Road are a number of rain gardens, installed by RBG as part of a Sustainable Urban Drainage Scheme and regeneration in the area completed in approximately 2021, shown in Photograph 13. Prior to the installation of the rain gardens, it was understood the combined sewer surcharged on occasions. An assumption was made during the rain garden design that no infiltration would occur due to the land previously being marsh land so the raingardens were lined. Overflow gullies are located within the rain gardens. On inspection, many of these gullies were blocked with debris and soil as shown in Photograph 14, partly due to the large grate size. The inlets and outlets were not visible on some of the gullies. It was also not clear how water was intended to enter the SuDS features, the rain gardens themselves were above road level. There was also evidence of sand and soil on the road surface which has been washed out from the rain gardens, suggesting water was flowing out from the rain gardens onto the impermeable road surface.

- 2.3.26 Video evidence provided by RBG of the flood event on 13<sup>th</sup> November 2023 shows a surcharging manhole in the highway. This manhole was not mapped on the TWUL dataset provided so its ownership is unknown. Four gullies were identified during the site visit either side of the underpass, which do not appear to be on RGB mapping (only two are present). These were also blocked.

- 2.3.27 It is likely that surface water will flow to the lowest elevation on White Hart Road, the railway underpass. In addition, the rain gardens are not able to function effectively as water is unable to enter the gullies due to blockages and the bed levels of the rain gardens are raised above road level. This increased volume of surface water may result in ponding or exceeded drainage capacity at the lower elevations.

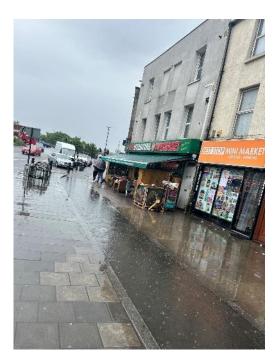
Photograph 15: Flooding to the cycle lane outside

- 2.4.17 Video evidence shown during the site visit by 151-152 Plumstead Roadshowed the whole of the westbound lanes of Plumstead Road, including the cycle lane and footpath, underwater at 6:20am on 28<sup>th</sup> April 2024 and reported water came into the store 3-4 inches deep.

- 2.4.25 Through the assessment of flood mechanisms, several recommendations for improvement have been identified:
  - RBG should replace the road gullies with gullies with gratings to prevent large debris from entering the system
  - TWUL should investigate whether discharging and failure to discharge from Crossness Pumping Station is causing the drainage network to backup at Plumstead Road
